Brněnec project. Preservation of architectural surfaces. Concept # 1

Löw-Beer Factory, Schindler's Ark

Scientific advice: Ivo Hammer (on-site inspection together with Dr. Daniel Low-Beer,
Saturday, June 5, 2021)

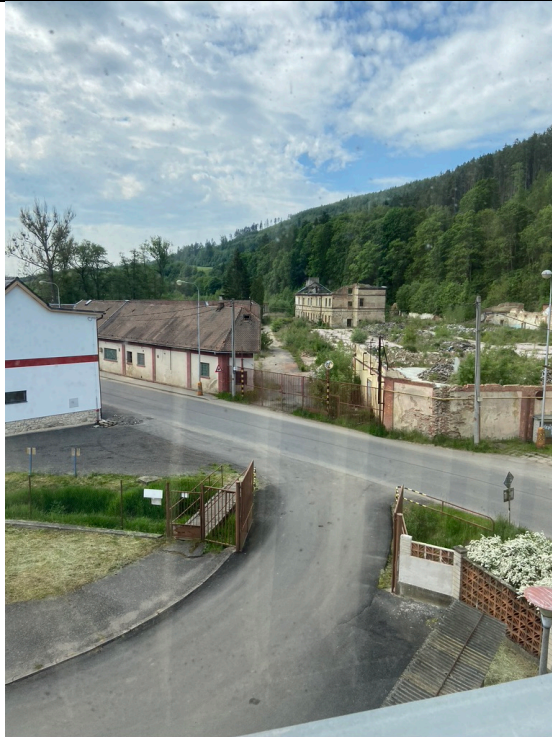
The largely destroyed southern part of the factory site: right. Remains of the surrounding wall of the weaving mill, in the middle in the background: partially destroyed dye works (warehouse for finished products), left. Garages; all left The renewed fire station. Photo: Ivo Hammer 2021

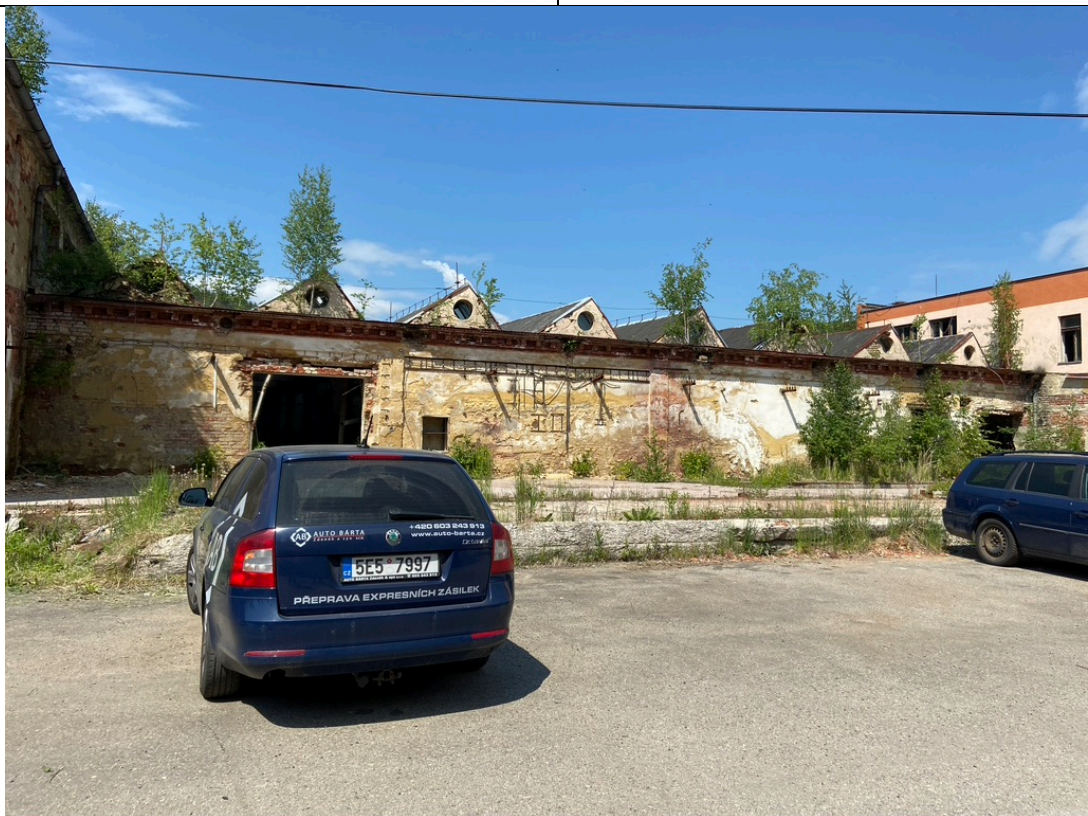
Spinning mill from approx. 1890, outer facade of the southernmost part, the later) vestibule has been removed; Structure of the smooth plastered façade with pilaster strips and serrated eaves made of brick, originally presumably yellowish-white lime paint, later several whitewashes in yellow and pink. The oculi of the hypetheral roof are bordered with fascia. The eaves of the roof gable may have originally only been protected with sheet metal. Photo: Ivo Hammer 2021

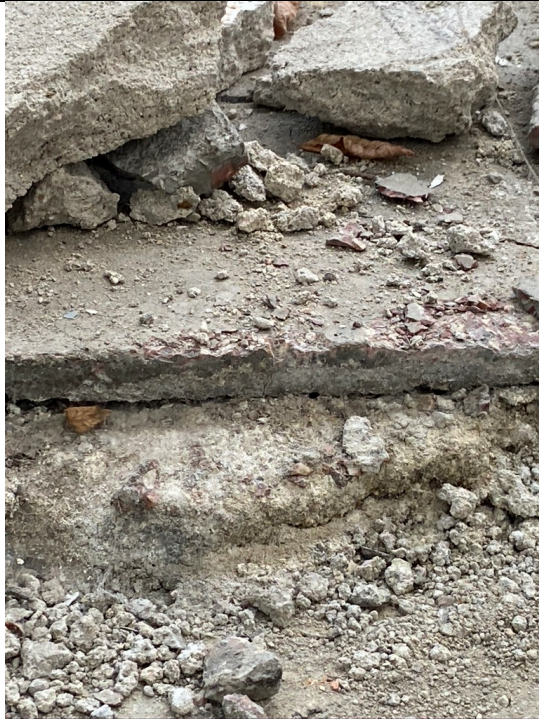
Spinning mill from approx. 1890, northern interior, broken edge of a machine pit: Under the destroyed recent concrete messenger, a possibly original slab of red terrazzo. Photo: Ivo Hammer 2021

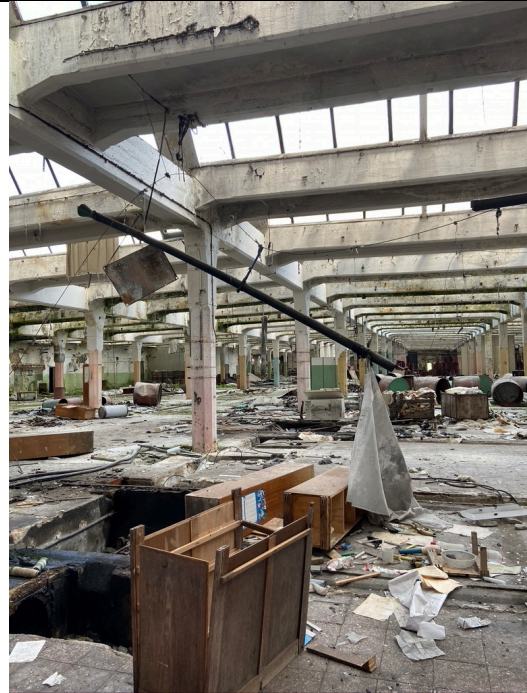
Spinning mill from approx. 1890, northern interior, machine pit and the rest of the heating pipes below the cross member. Photo: Ivo Hammer 2021

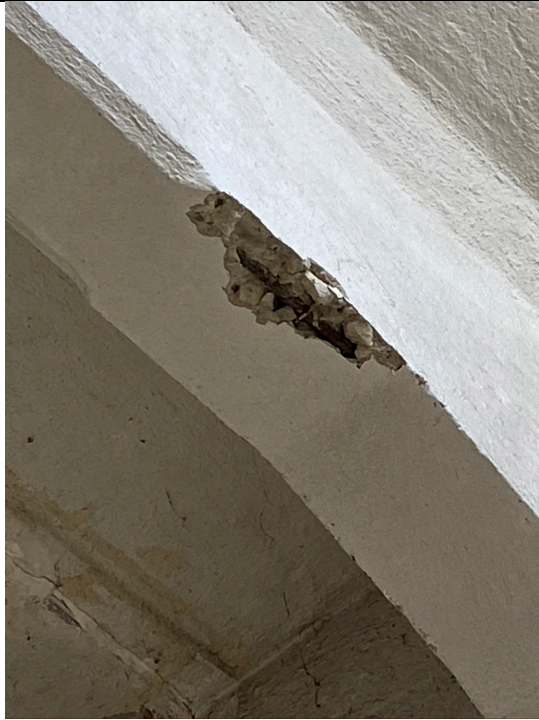
Spinning mill from approx. 1890, northern (?) Interior, detail of a cross member. The gray cement mortar and the reinforcing iron are visible in the mechanical damage.
Photo: Ivo Hammer 2021

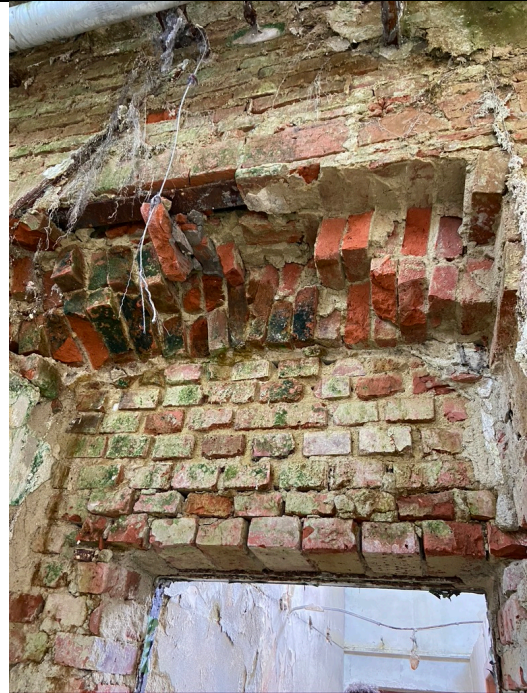
Spinning mill from around 1890, northern interior, east wall, detail. The brownish masonry mortar is visible on the broken-out segmental arch overlay of the door.
Photo: Ivo Hammer 2021

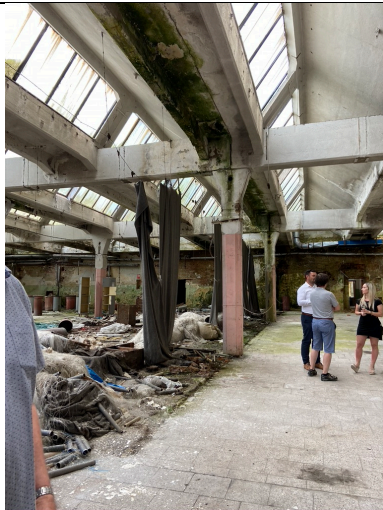
Spinning mill from approx. 1890, northern interior, joint between two yoke compartments in the side member and the cross member. In this area, the pillar is not monolithically connected to the girders.
Photo: Ivo Hammer 2021

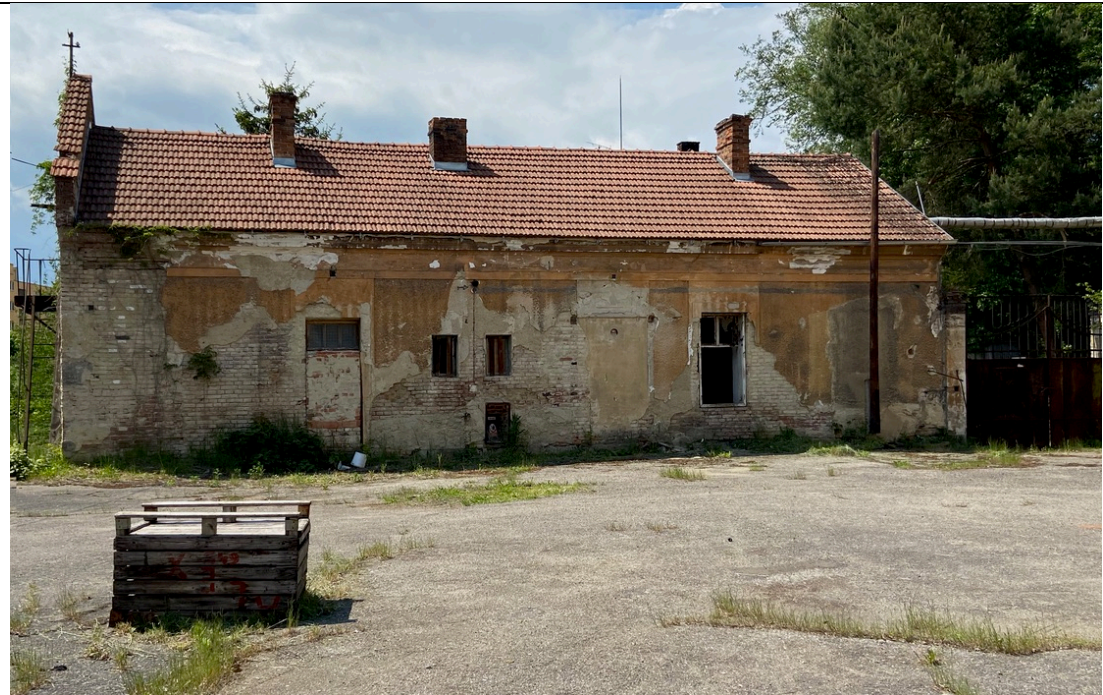
Residential building (management by Oskar and Emilie Schindler). Brick, block bond. Profiled eaves cornice. Raised south gable. 3 (?) Chimneys. Walled up doors. A window walled up with cement mortar. Photos: Ivo Hammer 2021

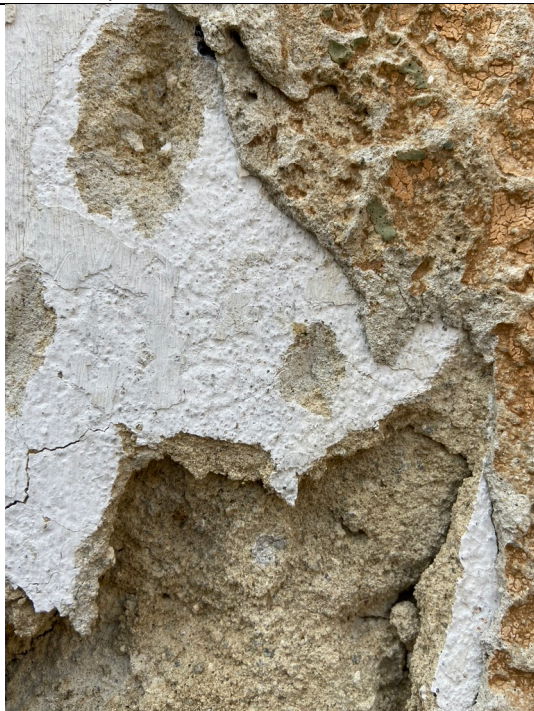
Residential building (management by Oskar and Emilie Schindler), facade detail: base plaster with yellowish-gray mortar with fine lime sparrows (dry slaking), fine plaster with the same mortar, only finer grain size.

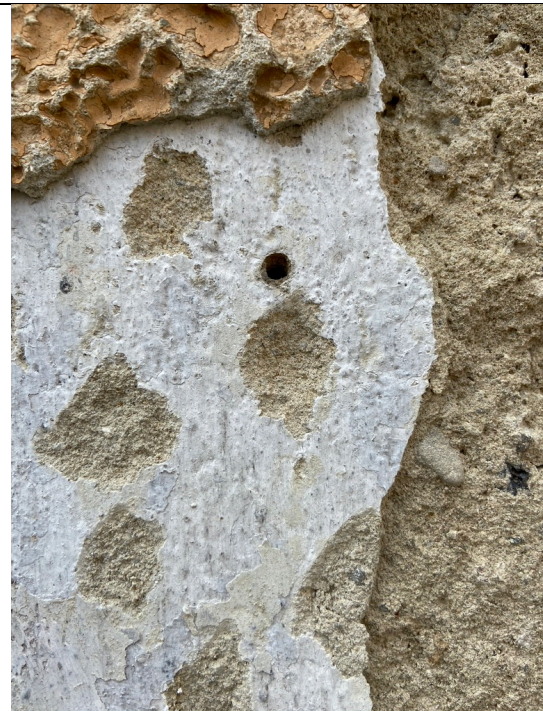
Rubbed surface, very light yellowish-white, thin Freko whitewash. 2 thin yellowish-white whitewashes. Stubby plaster with light gray mortar with fine lime sparrows, possibly natural plaster 3 whitewashes: brown, light red-brown, green. Photos: Ivo Hammer 2021

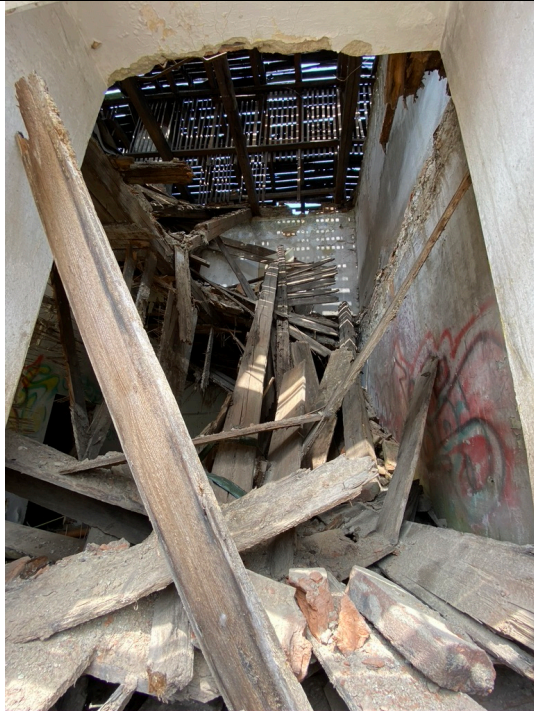
Former laboratory and workshop (SS-Bau des KZ Brnenec, German building). Look into the window to the left of the center entrance. Devastated interior. Photos: Ivo Hammer 2021

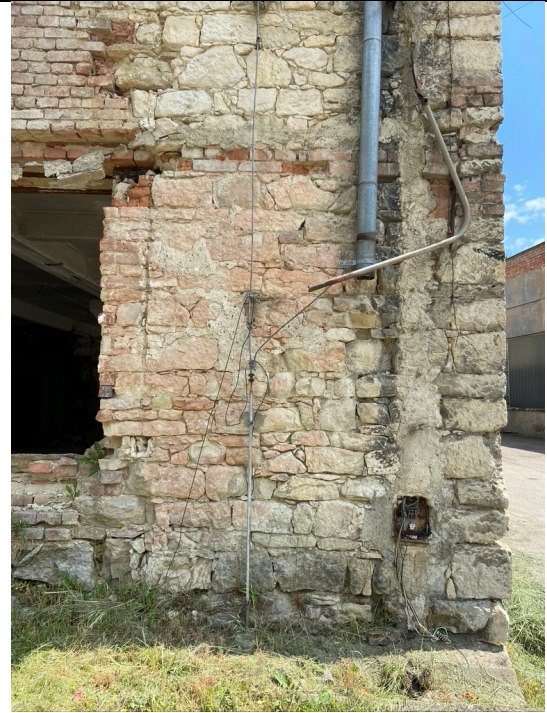
Local pink discoloration of the stone from the source of the fire.

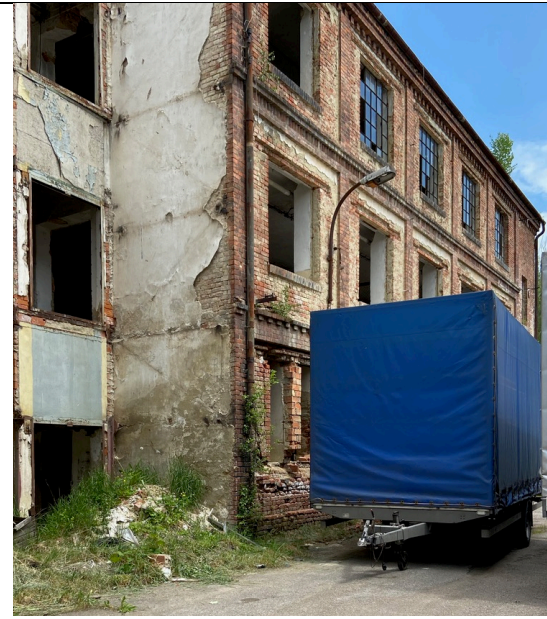
Right: (partially covered by a trailer) annex to the dye works: bricks, irregular structure, facade structure with pilaster strips, belt cornices with serrations and profiled eaves cornice. Flat roof. Lined window lintels made of double T-beams, cantilevered sills made of a group of bricks. The zero surface plastered smooth and whitewashed yellowish, the structure brick-faced (or red)? On the west wall of the Anex building, traces of a former external staircase (?), Which correspond in height to the adjoining wall openings, with smooth, yellowish-white plaster (damaged at the corners).

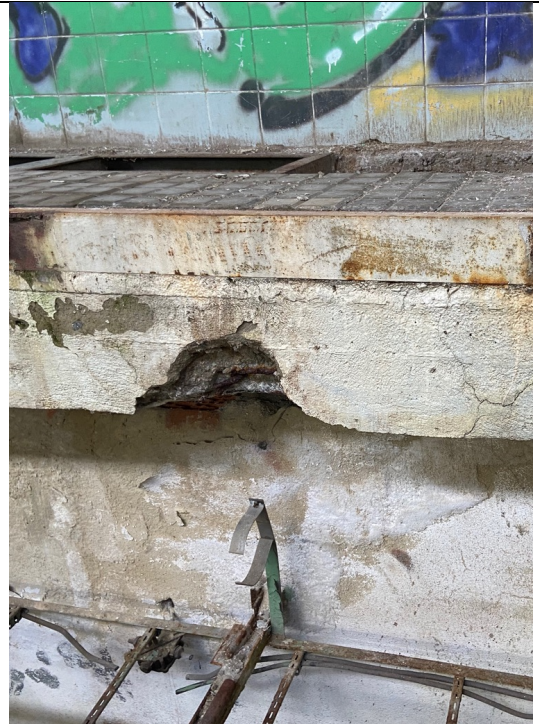
Schindler's Ark, dye works, concrete
reinforcement

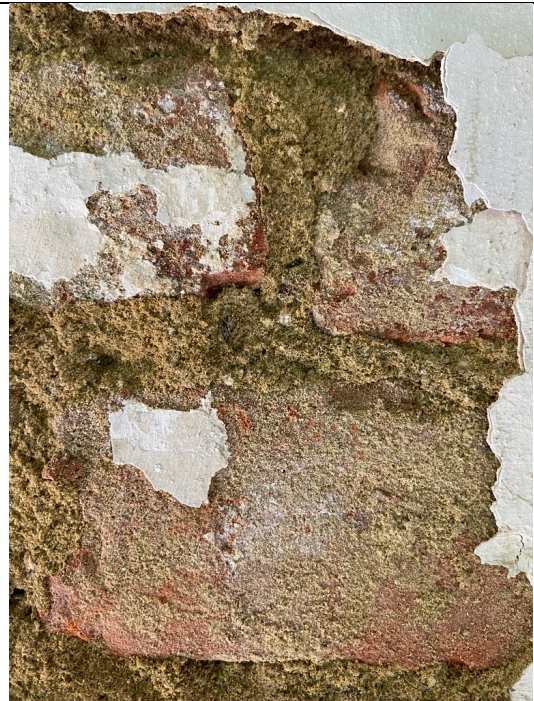
Schindler's Ark, 2nd floor, reinforced concrete hall, northern annex room, view to the south, detail: bricks, brownish masonry mortar, yellowish white lime whitewashes. 1-2 later whitewashes. Photo: Ivo Hammer 2021
