Brněnec project. Preservation of architectural surfaces. Concept # 1

Löw-Beer Factory, Schindler's Ark

Scientific advice: Ivo Hammer (on-site inspection together with Dr. Daniel Low-Beer,
Saturday, June 5, 2021)

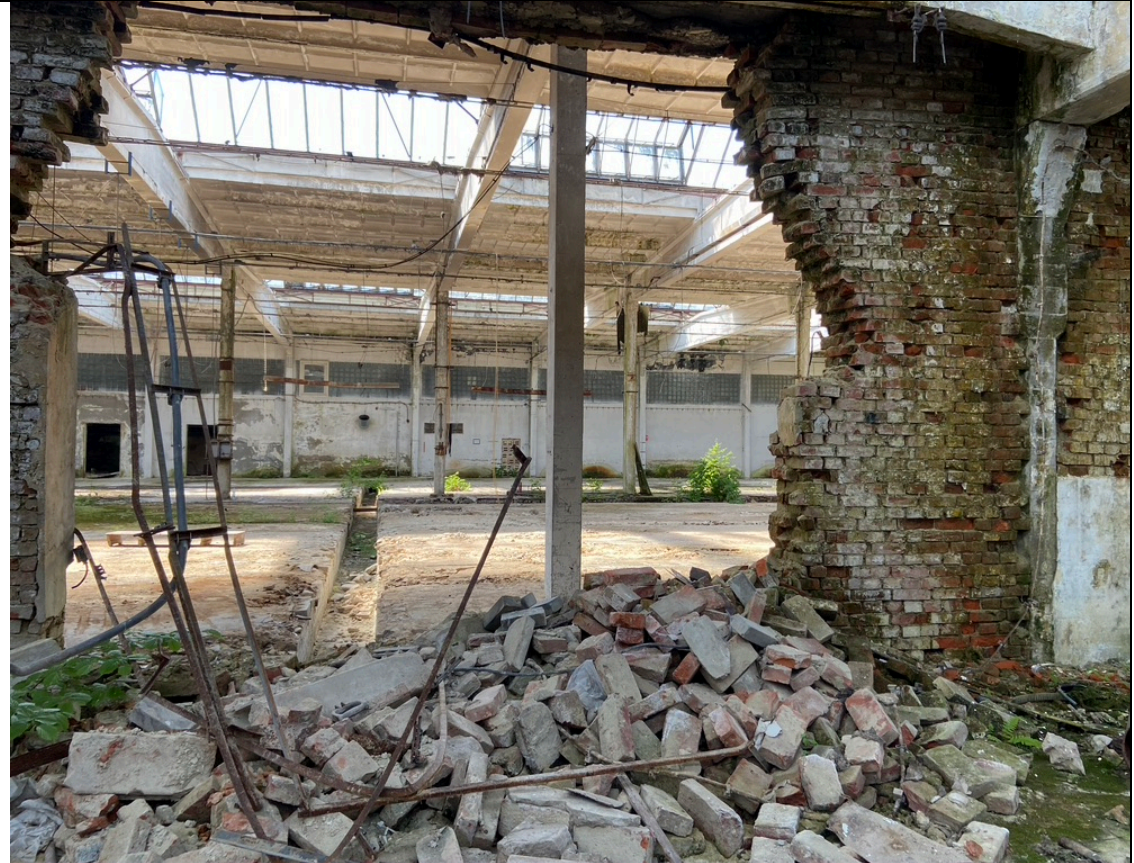
Newer hall in the south of the spinning mill, north of the administration building, transversely positioned, with two aisles in north-south direction, approx. 8 aisles in east-west direction, with slender, square pillars. The double-T-shaped, slightly gabled (prefabricated?) Concrete girders span one of the two ships in a north-south direction. The overlays on the girders consist of U-shaped elements with partially exposed reinforcing bars. In the area of the middle of the girder there is a gable hypäthral light band made of windows in steel frames, with ventilation devices. The south wall contains a light band made of 7 rows of glass bricks.

In the foreground the openwork south wall of the spinning mill: block bond, thickness approx. 45 cm (truss and stretcher), the concrete pillar walled in. Remnants of plaster and whitewash. Photo: Ivo Hammer 2021

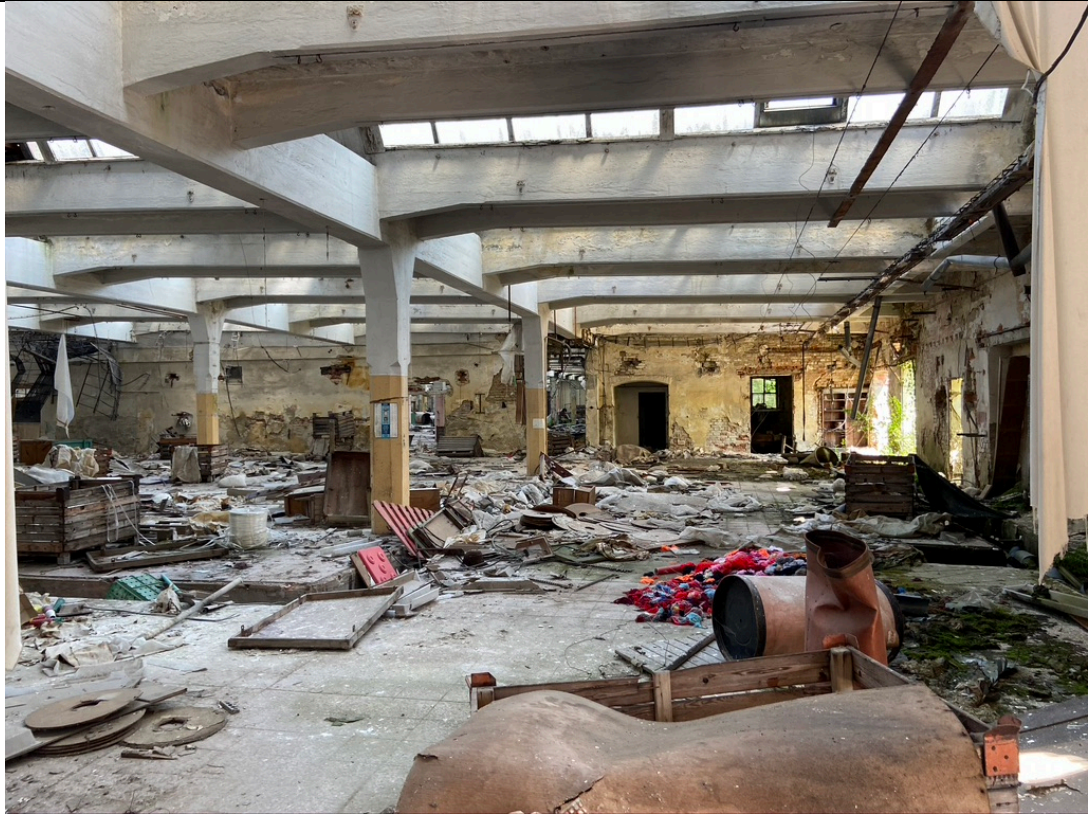
Spinning mill from approx. 1890, south interior, view to the north.

Possibly the earliest monolithic concrete structure based on the Hennebique system, patented in France in 1892 (see I. Hammer, 2021), with hypetheral lighting.

6 (?) Naves, a total of approx. 30 (?) Yokes. Floor originally perhaps red terrazzo (?). Square pillars chamfered up to a height of approx. 3 m, three yokes each are connected with a high rectangular beam. Each pillar and additionally the center of each yoke are connected with U-shaped transverse girders, each of which protrudes slightly beyond the longitudinal girder and is pulled down a bit at the point of attachment and is thus higher. The lower edges of the girders and the cross girders are chamfered up to the pillars. A gable sits on the vertical beam of the U-girder, which is completely closed with formwork concrete on the south side and a stile reinforced at the gable base on the north side in the pillar area. The ribbon windows are glazed in steel frames, 8 windows per nave, one of which (in some areas) has a ventilation device. The western and southern outer walls or the partition walls, bricked in block bond and stretcher-binder thickness with a brownish mortar (Roman cement?), Or the partition walls were plastered with a brownish mortar (possibly only one layer, which is possible with a hydraulic lime mortar), the surface probably rubbed and probably painted with a whitewash colored with fine silicate particles of sand.

The concrete parts, like the plastered brick walls, are likely to have been painted with the same yellowish-white whitewash. Photo: Ivo Hammer 2021

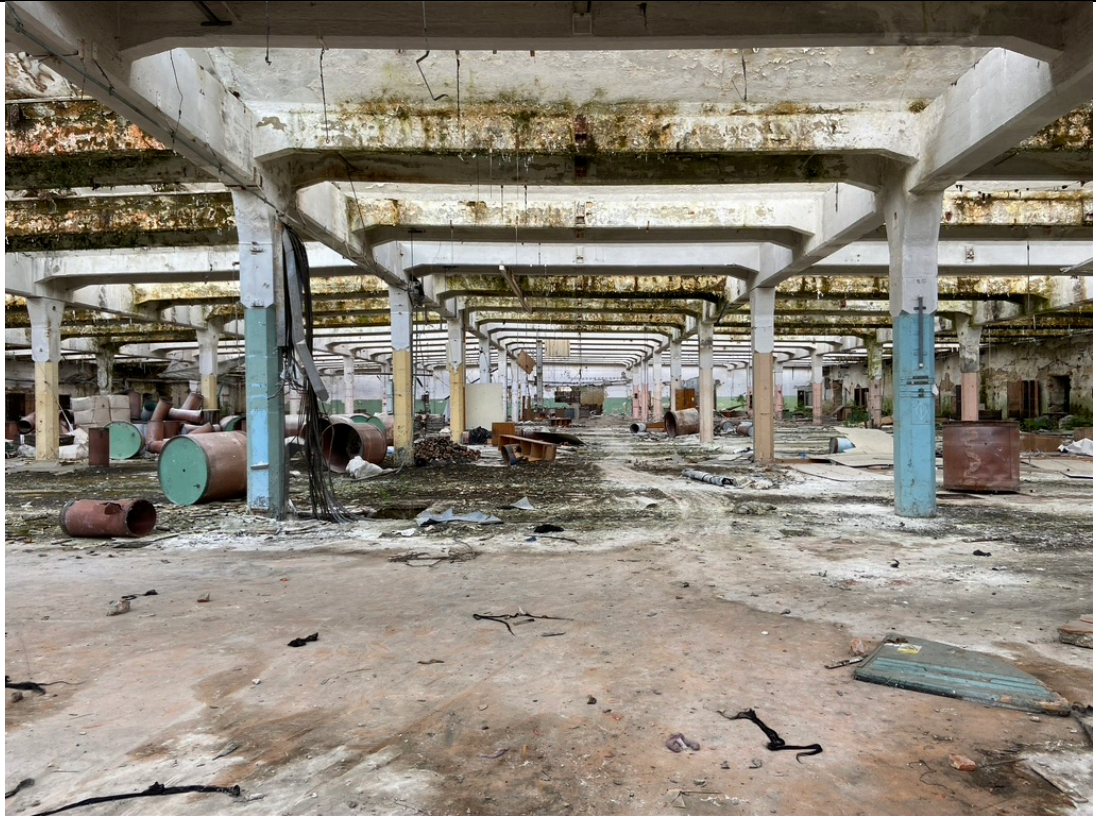
Spinning mill from approx. 1890, northern interior, looking north. Photo: Ivo Hammer 2021

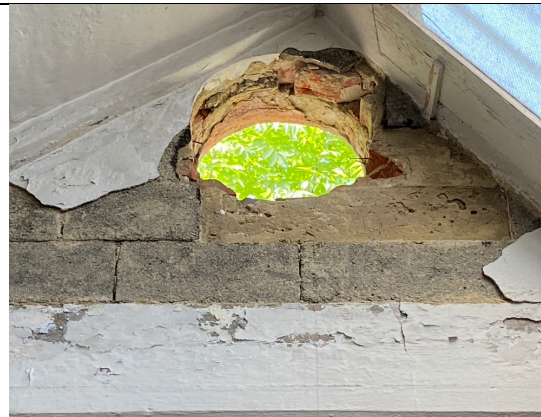
Spinning mill from approx. 1890, southern interior, western oculus of the gable wall of the hypäthral light. The inside of the gable wall is coated with panels that are black at the break edge. Possibly slag and bitumen or cement (?) Panels. The panels are probably used for thermal insulation. Photo: Ivo Hammer 2021

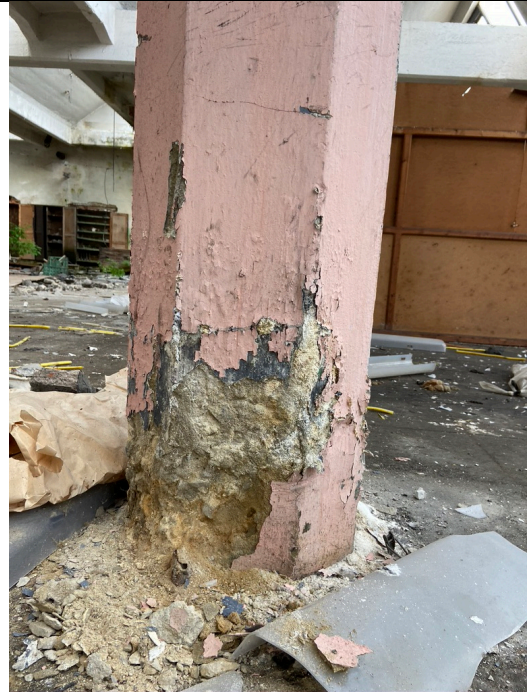
Spinning mill from approx. 1890, south interior, detail of a pillar. The cement is the brownish Roman cement. A touch up? Photo: Ivo Hammer 2021

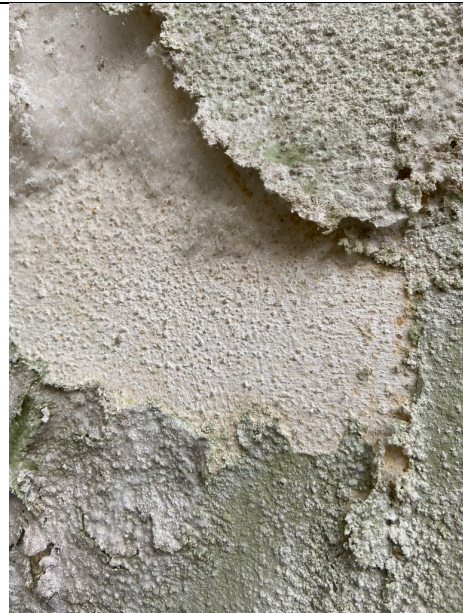
Spinning mill from approx. 1890, northern interior, detail of the west wall. Possibly original rubbed and whitewashed surface.
Photo: Ivo Hammer 2021

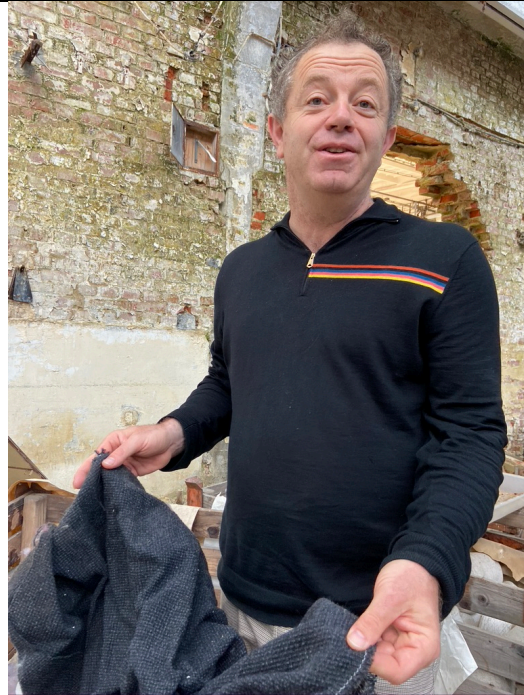
Spinning mill from approx. 1890, southern interior, devastated in 2012 (?). Daniel Low-Beer with the rest of a fabric product.
Photo: Ivo Hammer 2021

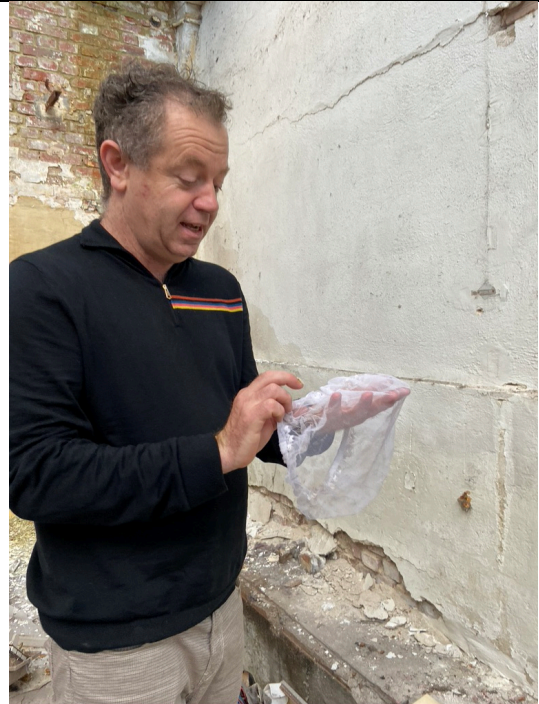
Spinning mill from approx. 1890, southern interior, devastated in 2012. Daniel Low-Beer with a textile worker's* hair protection. Photo: Ivo Hammer 2021

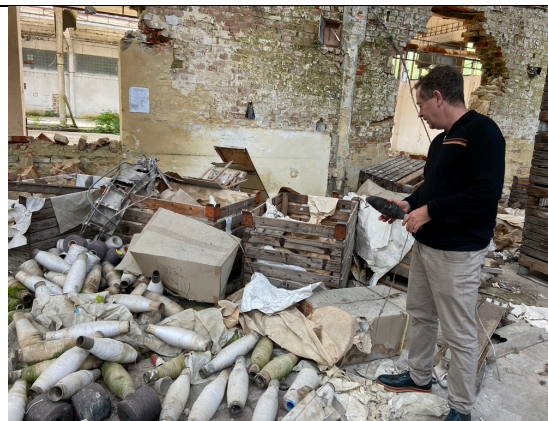
Spinning mill from approx. 1890, southern interior, devastated in 2012 (?). Daniel Low-Beer with the rest of a fabric product.
Photo: Ivo Hammer 2021

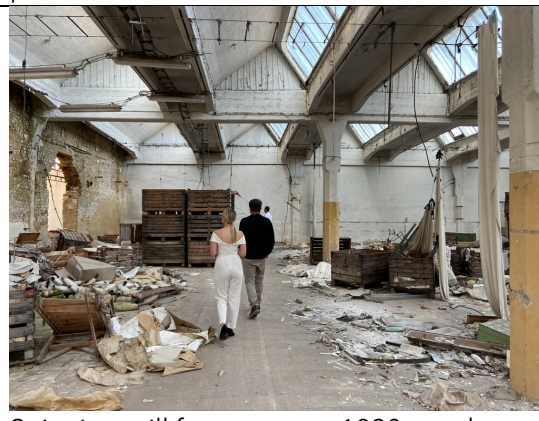
Spinning mill from approx. 1890, southern interior, devastated in 2012 (?). Photo: Ivo Hammer 2021

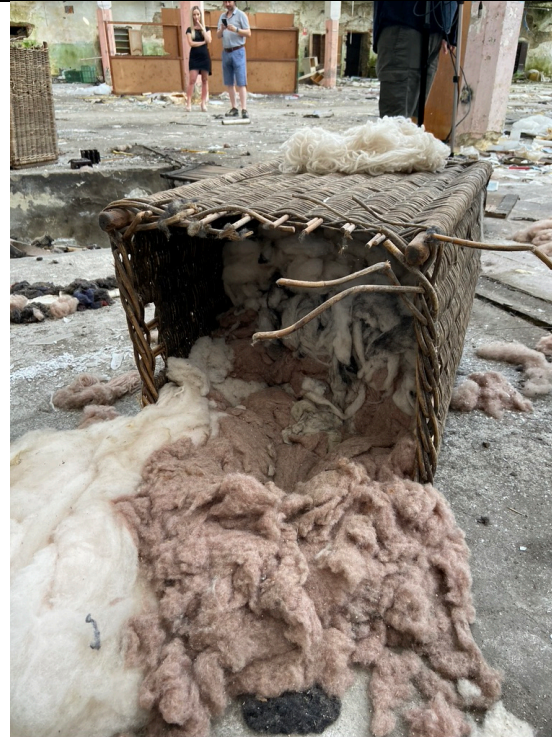
Spinning mill from around 1890, northern interior, devastated in 2012 (?). Basket with raw wool. Photo: Ivo Hammer 2021

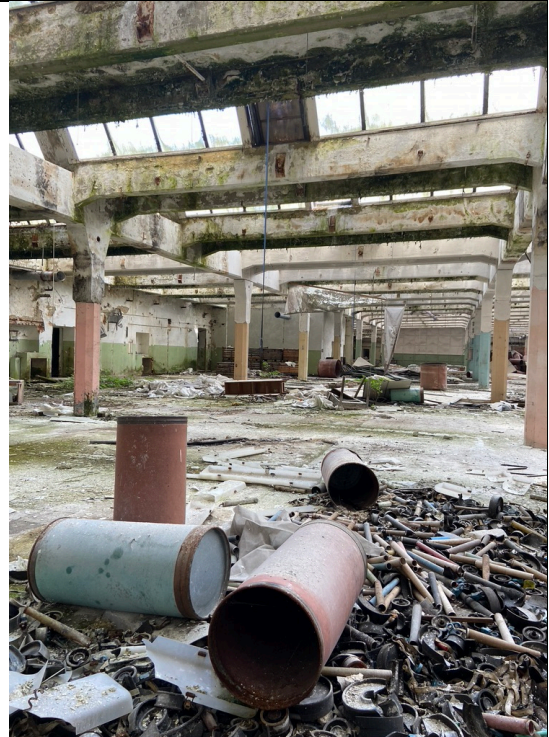
Spinning mill from approx. 1890, northern interior, devastated in 2012 (?), Remains of spinning machines. Photo: Ivo Hammer 2021

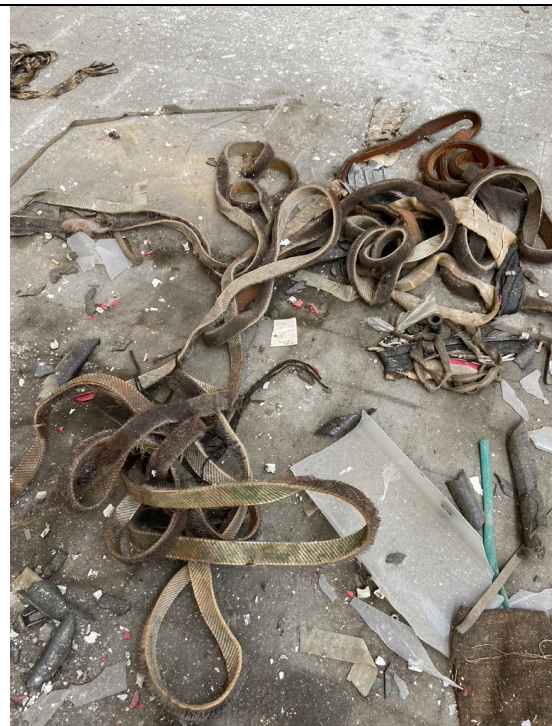
Spinning mill from approx. 1890, northern interior, devastated in 2012 (?). Ribbons for carding wool. Photo: Ivo Hammer 2021

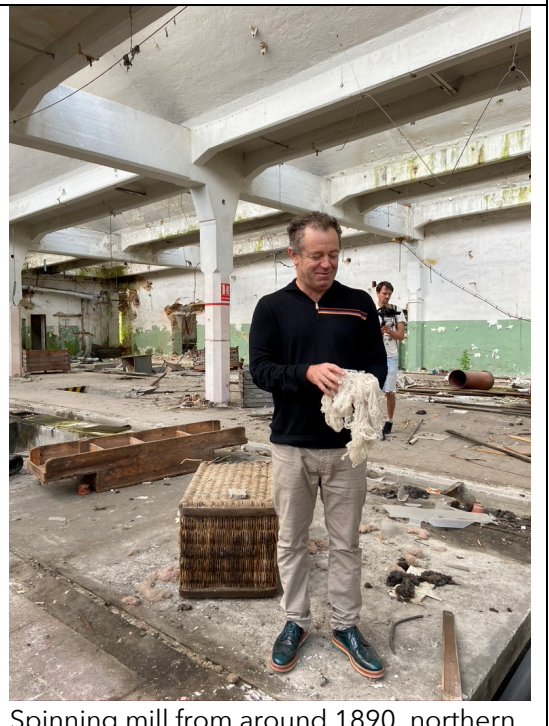
Spinning mill from around 1890, northern interior, dies in 2012 (?). Daniel Low-Beer with intermediate product from wool spinning. Photo: Ivo Hammer 2021

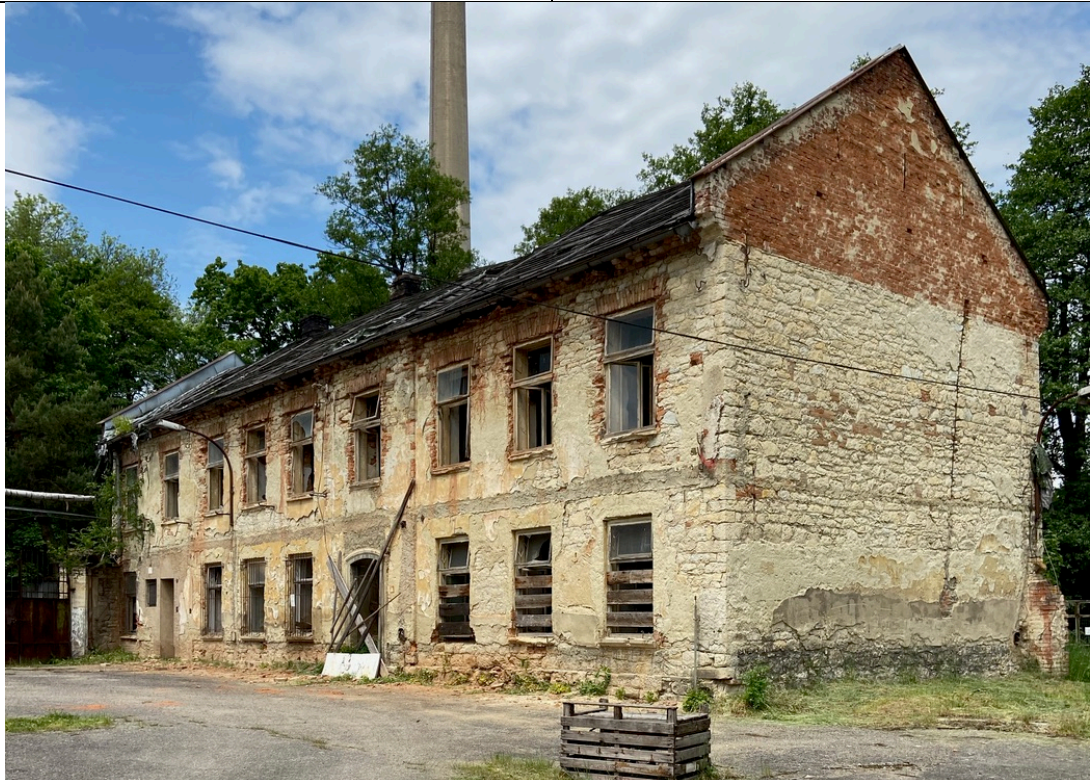
Former laboratory and workshop (SS-Bau des KZ Brnenec, German building). 2 construction phases: stone masonry mixed with bricks, 2 storeys. Gable wall built with brick. The windows on the upper floor possibly enlarged with brick, with a wedge-shaped brick lintel. Both gable walls raised. 2 chimneys in the east. Roof covered (2012?), Only the roof battens left. Completely devastated inside. Remains of plaster and whitewash preserved on the south facade. Window frames and window sashes still partially preserved. Photos: Ivo Hammer 2021

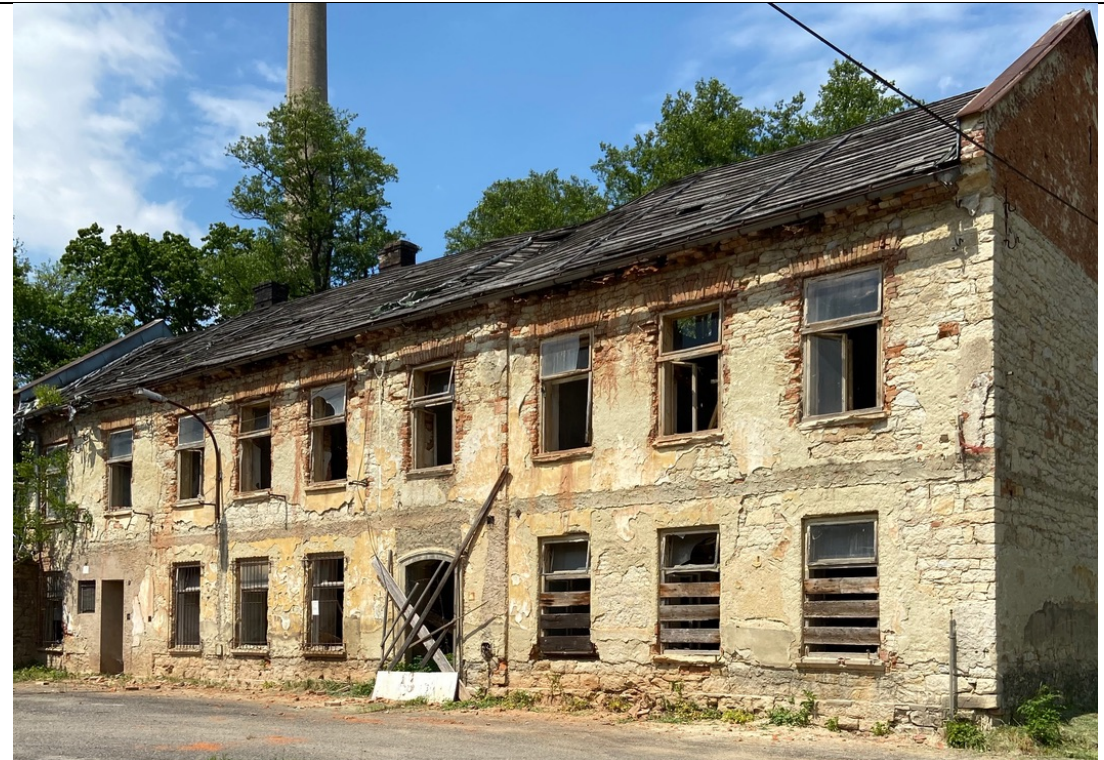
Former laboratory and workshop (SS-Bau des KZ Brnenec, German building). South facade. Profiled door frame with segmented lintel. Remnants of a tooth cut eaves.

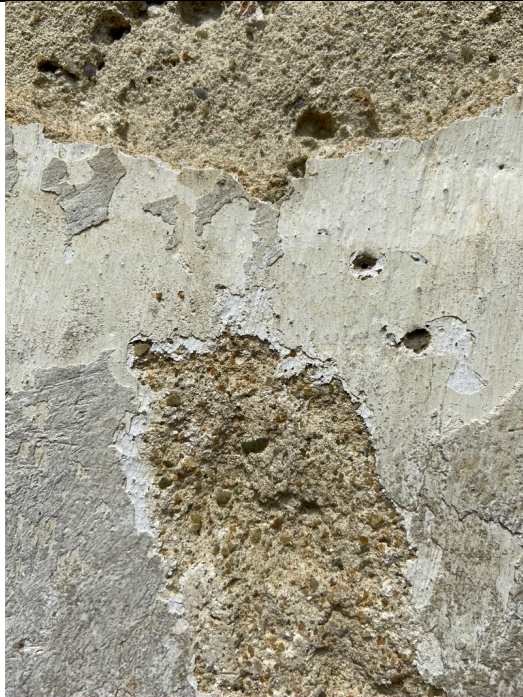
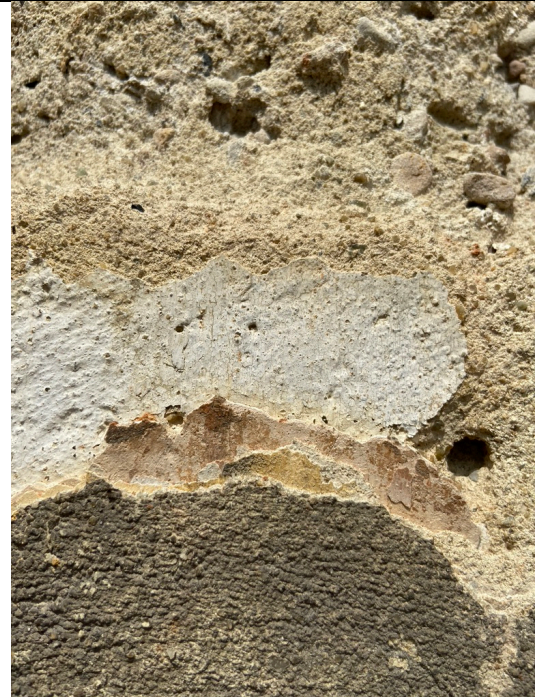
Former laboratory and workshop (SS-Bau des KZ Brnec, German building). Details of the south facade (lower edge of the picture approx. 10 cm). Base plaster with yellowish-gray mortar with fine lime sparrows (dry slaking),

Fine plaster with the same mortar, only finer grain. Rubbed surface, very light yellowish-white, thin Freko whitewash. Approx. 5 whitewashes. Recent rub from (lime) mortar.
Photos: Ivo Hammer 2021

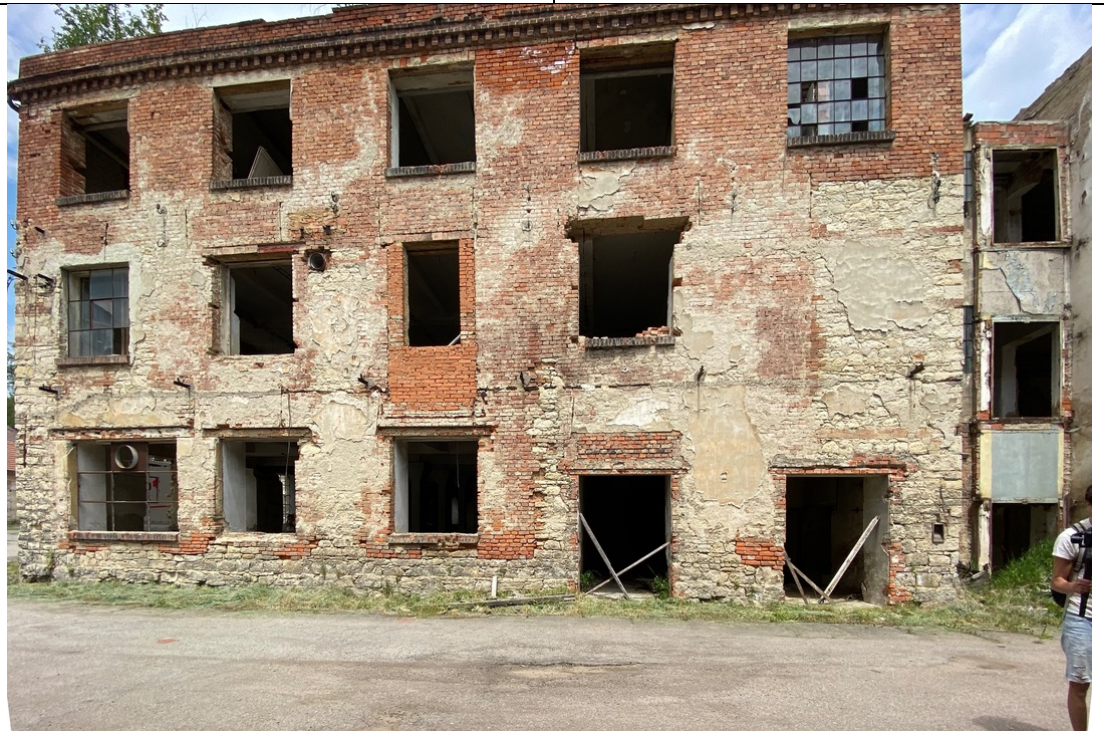
Brnenec, Schindler's Ark, south facade. On the east facade, a secondary staircase is installed in the space between the adjoining building. Rebuilt several times.

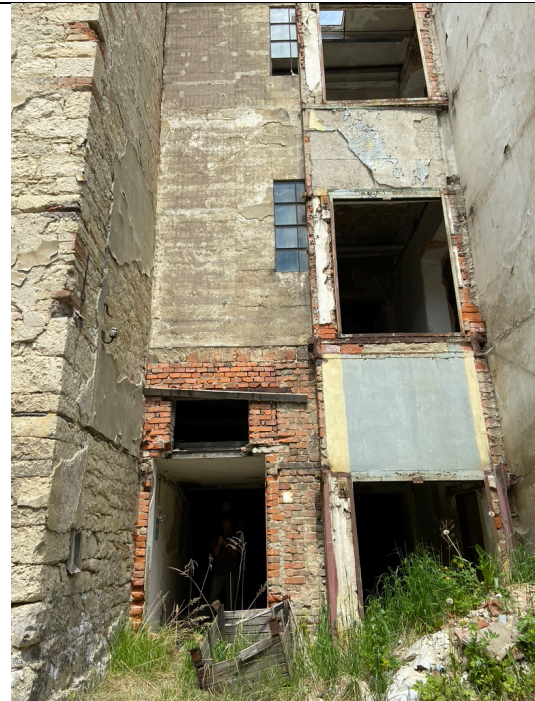
Between Schindler's Ark and the annex building of the dye works. On the right the structure possibly corresponding to the adjoining external staircase: steel girders with brickwork, HERAKLITH panels (wood wool with Sorel cement), plastered and leftover paint: yellow, gray (probably organic binder) and yellowish-white (lime) whitewash.

On the left on the ground floor a very irregular brick structure, the door opening has a lintel from a steel beam. Above a window opening with wooden elements. Above the brick structure, the roughly paved concrete wall of a stairwell with side windows. Traces of yellowish white whitewash and remnants of a smoothed (?) (Cement) plaster without whitewash.

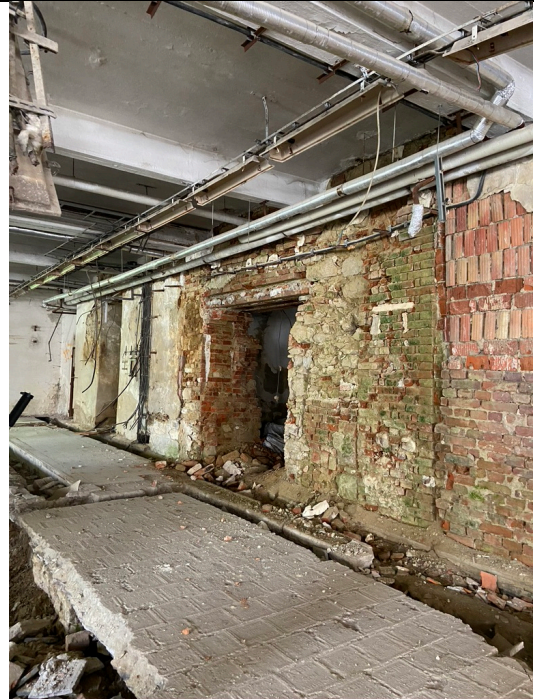
Schindler's Ark, ground floor, reinforced concrete hall, view to the northeast. Breakthrough through stone and brick wall. Bricking up a window. Photos: Ivo Hammer 2021

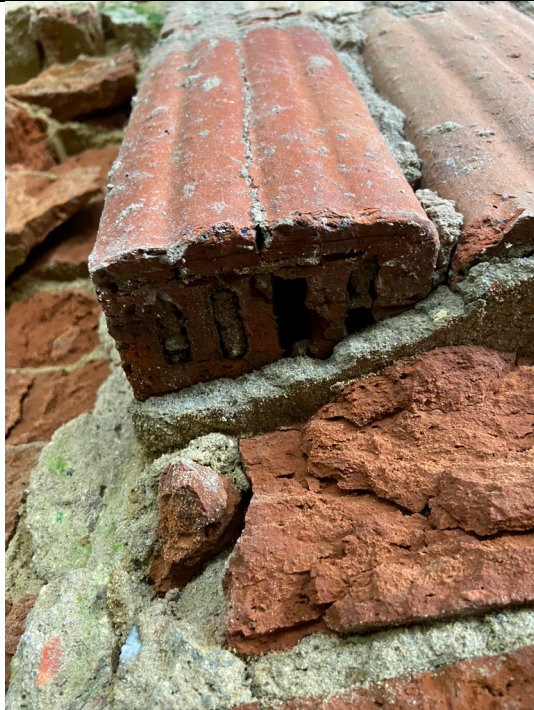
Detail of the walling up of the window

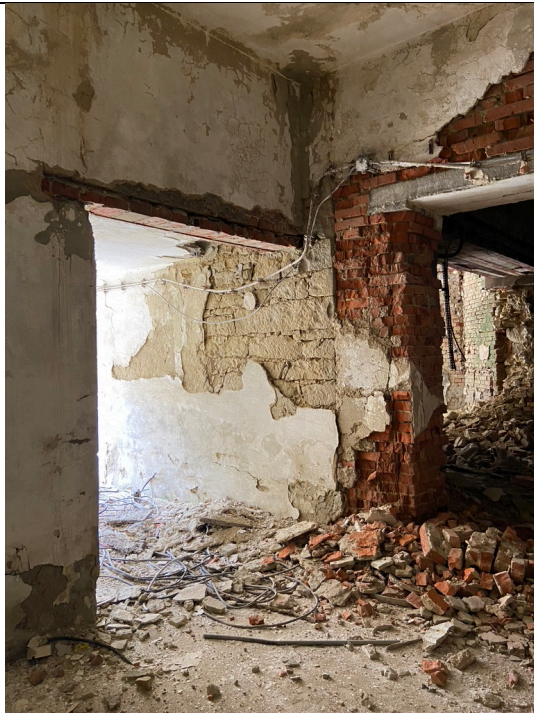
Schindler's Ark, ground floor, room east of the reinforced concrete hall. Stone masonry rebuilt with bricks.

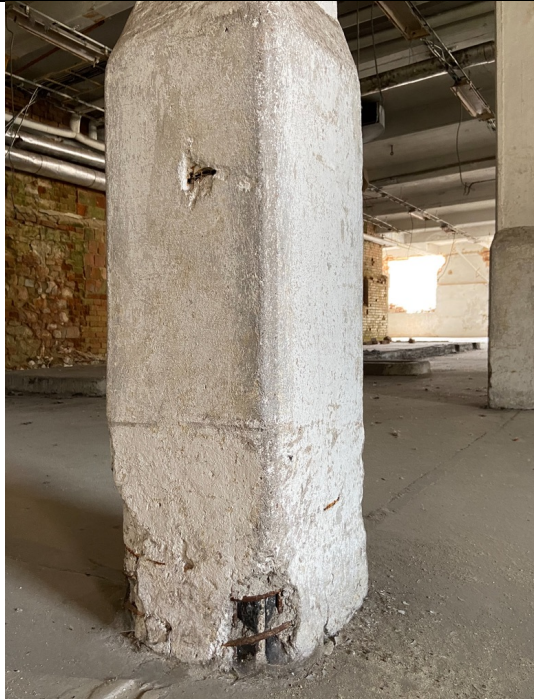
Schindler's Ark, 2nd floor, reinforced concrete hall, view to the southeast, detail: reinforcement of the pillar with reinforced concrete. Photos: Ivo Hammer 2021

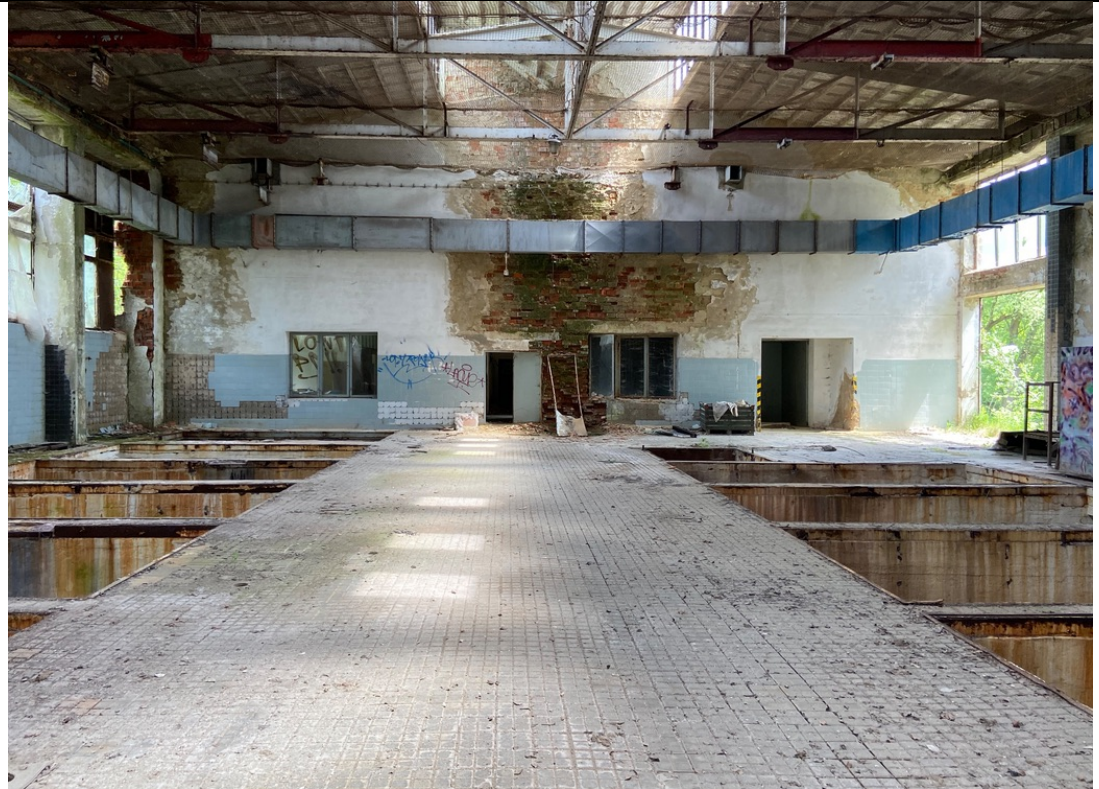
Schindler's Ark, dye works, looking east.
Concrete tiles of the floor with wedge joints. The steel structure of the roof with ribbon windows opening to the north and south. Photos: Ivo Hammer 2021

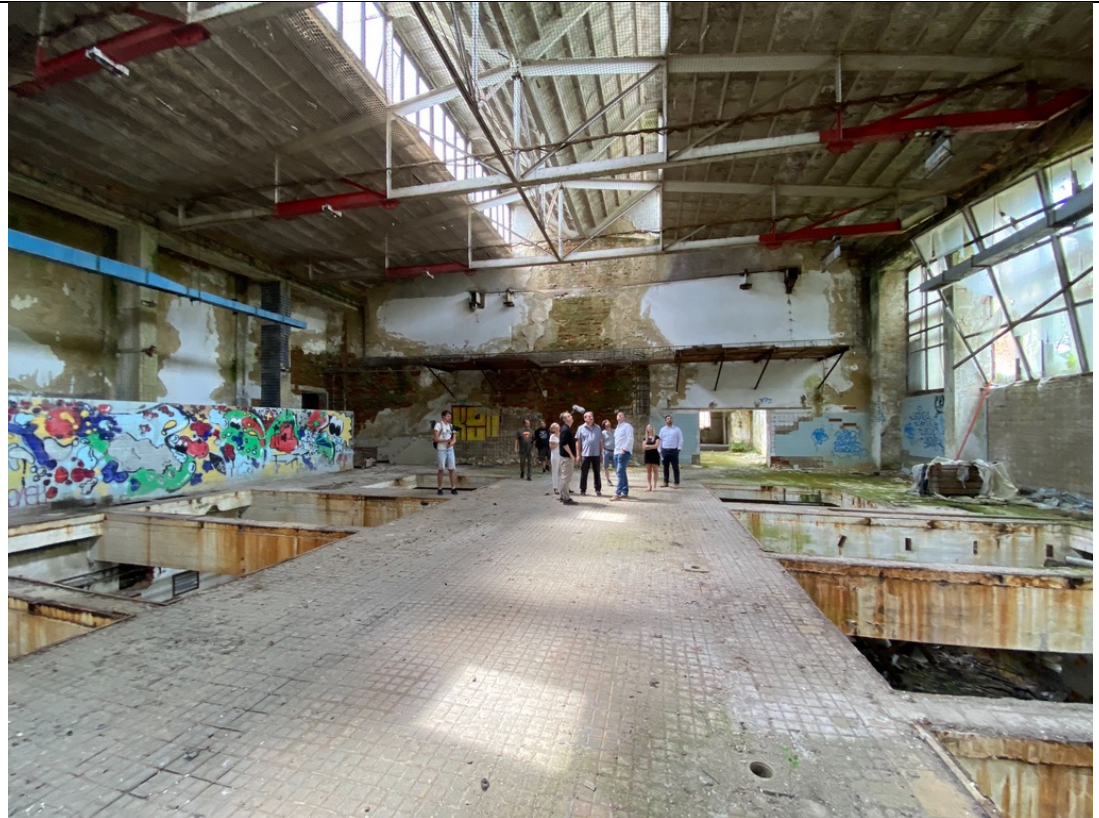
Schindler's Ark, dye works, looking west.

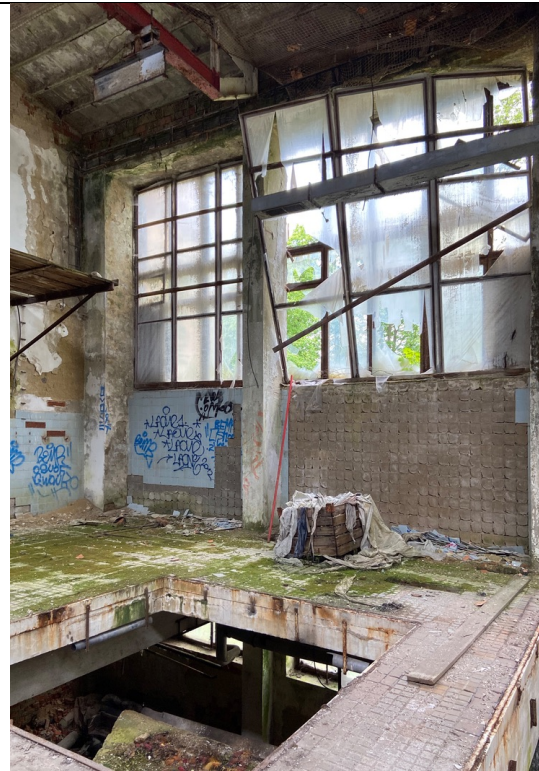
Schindler's Ark, dye works, northwest corner. Remnants of the crane

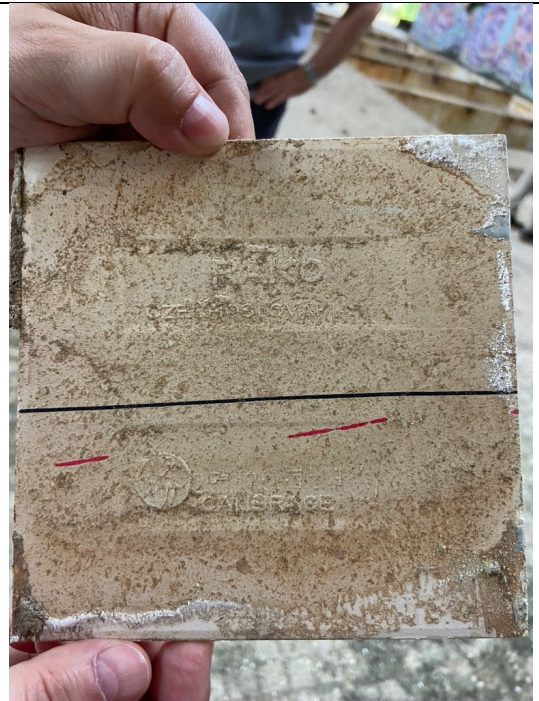
Schindler's Ark, dye works. Back of a tile:
RAKO

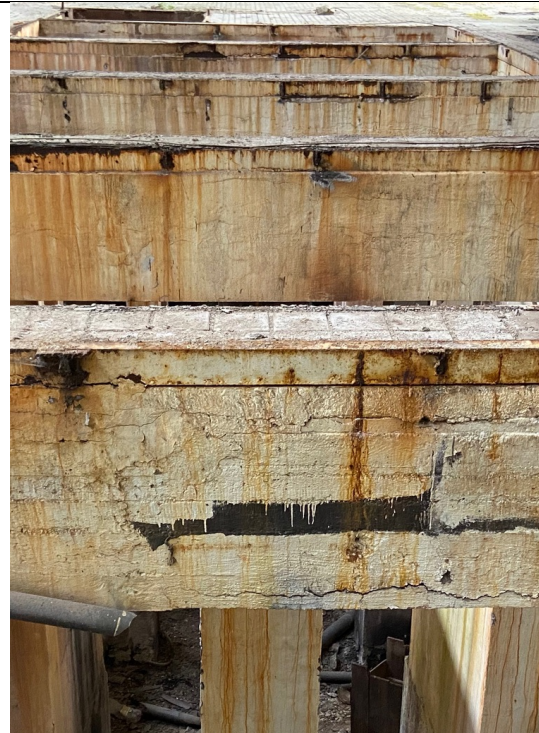
Schindler's Ark, dyeing, protective coating
(oil paint?)

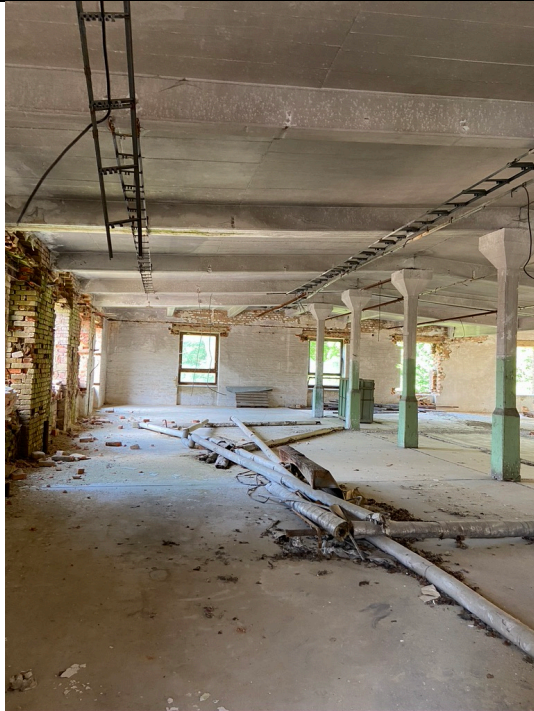
Schindler's Ark, 2nd floor, reinforced concrete hall, view to the south. Photo: Ivo Hammer 2021

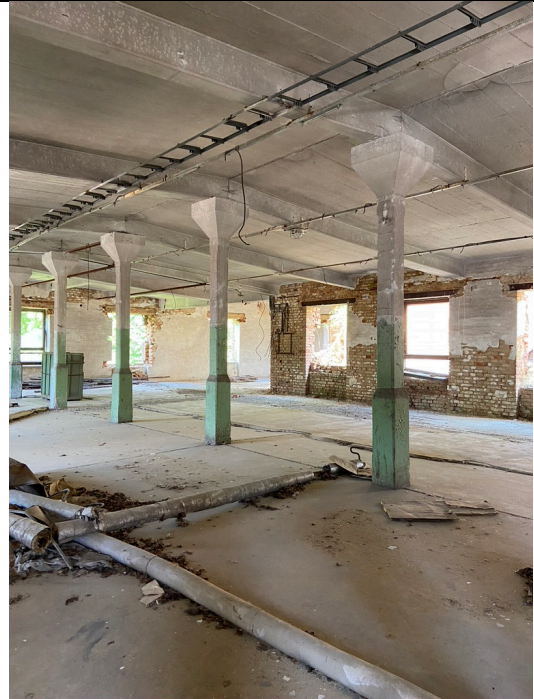
Schindler's Ark, 2nd floor, reinforced concrete hall, view to the northeast. Photo: Ivo Hammer 2021

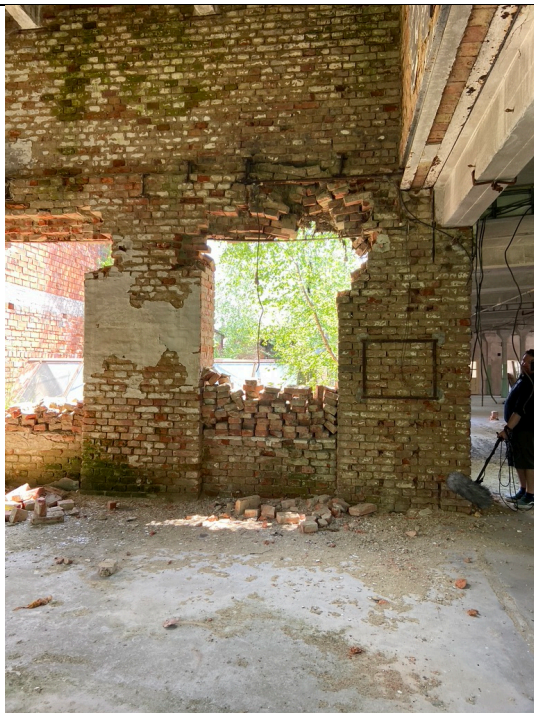
Schindler's Ark, 2nd floor, reinforced concrete hall, northern annex room, view to the south. Photo: Ivo Hammer 2021

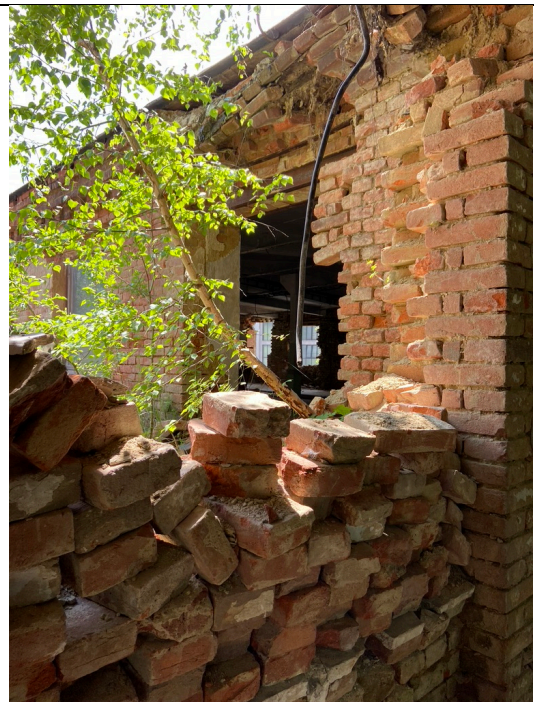
Schindler's Ark, 2nd floor, reinforced concrete hall, northern annex room, view to the southwest, detail. Photo: Ivo Hammer 2021

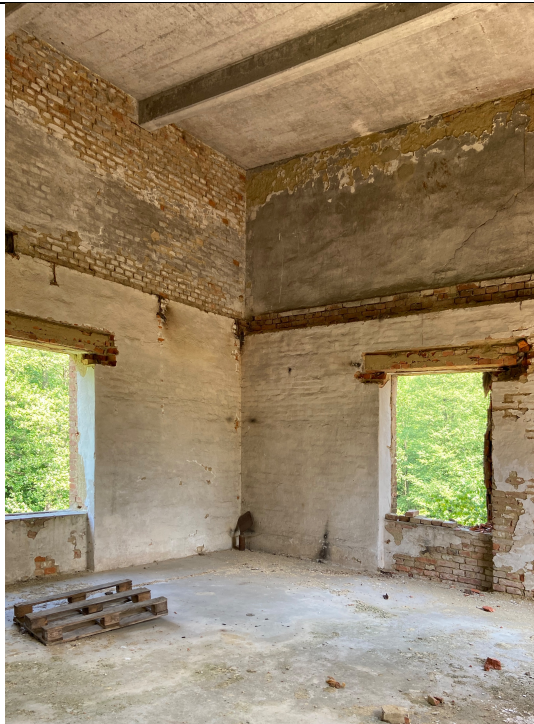
Schindler's Ark, 2nd floor, reinforced concrete hall, northern annex room, view to the northeast. Photo: Ivo Hammer 2021
